## บริษัท ที.จี. คอนโทรล จำกัด

# TCONTROL HTTP API Smart Sensor

# CONTROL HTTP API Smart Sensor (Auth Interface)

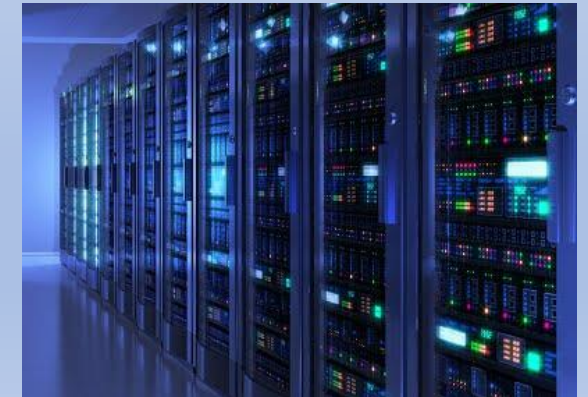
Application  
Smart Phone

Bluetooth

Cassia router

Smart Sensor  
Dashboard

API

Database Server

Auth
